Annual Report for 2006 NPDES Municipal Separate Storm Sewer System Permit

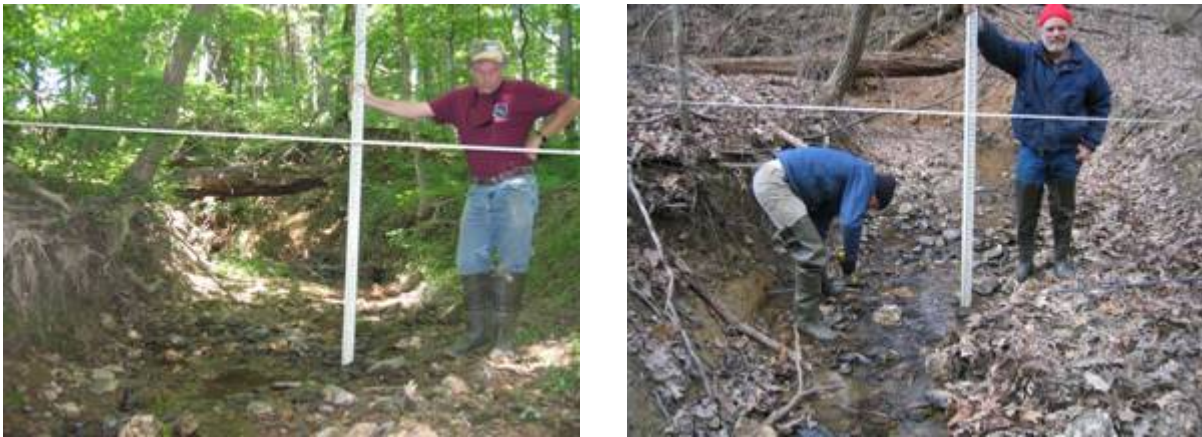
Figure III-D16. Sopers Branch Control Area 1 Cross Section 1- Facing Upstream

The geomorphological survey was scheduled in early spring beginning in 2006, rather than during summer when dense vegetation impaired the survey work. A secondary benefit was the improved level of detail in the photo documentation. For example, stream bank and top of bank condition as shown in Figure III-D16. In 2005, Area 2 of the control area was completely dry, but in 2006 there was flow, Figure III-D17. In test area 4, the stream has not changed drastically, but the tree that fell in 2005 just downstream of cross section 1 remained in place during 2006. Though not affecting base flow, it may impact the stream during a flood event.

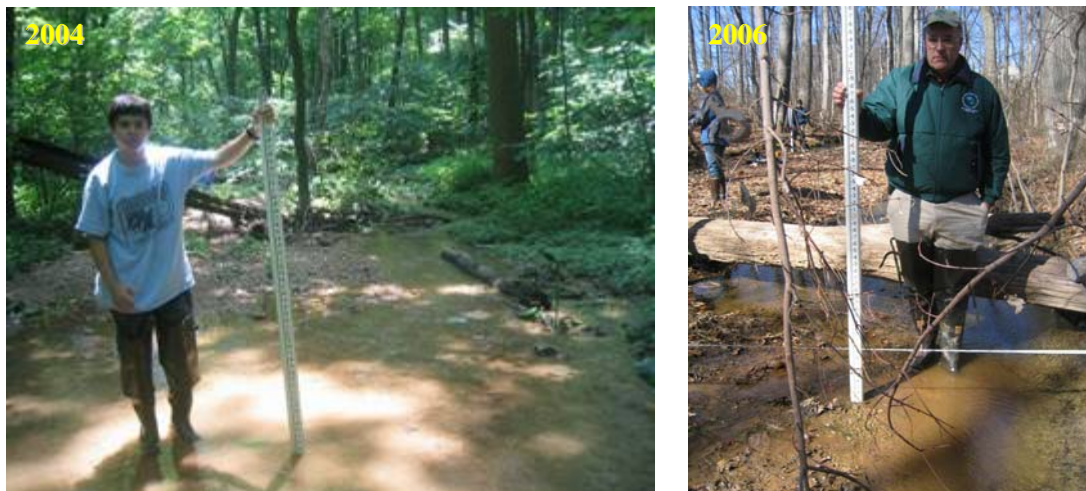
Figure III-D17. LSLS104 Test Area 4 Cross Section 1 - Facing Downstream

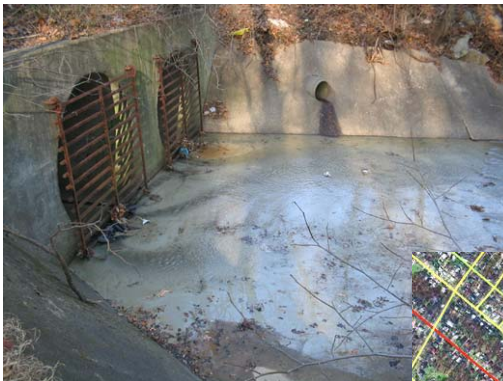
Figure III-E2. Maple Avenue Outfalls and Discharge Source Location.

Over the past 10 years, there have been recurring problems at twin 72" outfalls at Maple Avenue to Sligo Creek in Takoma Park. As shown in Figure III-E2, much of the drainage to these outfalls originates within the District of Columbia (DC). However, the storm drain inventory for Takoma Park and DC in this area were not available until 2008. Based on information in the DEP's case history files, it took almost 19 hours of staff time to track down the source of this discharge.

In January of 2006, a significant, grayish-white discharge was reported from these twin outfalls. After a site visit and no evidence of a source within Montgomery County, the DEP began source tracking in conjunction with DC environmental enforcement and the water and sewer authority. The investigation included dye testing within the storm drain system in both jurisdictions and eventually the origin was tracked to a well drilling operation at a building construction site in Northwest DC. The DC environmental compliance staff then initiated enforcement and corrective actions to prevent future discharges from this site.
